SAFETY NOTICE:- RESERVE DEPLOYMENT ISSUE ON SUP' AIR ALTI X AND EVO XC HARNESSSES

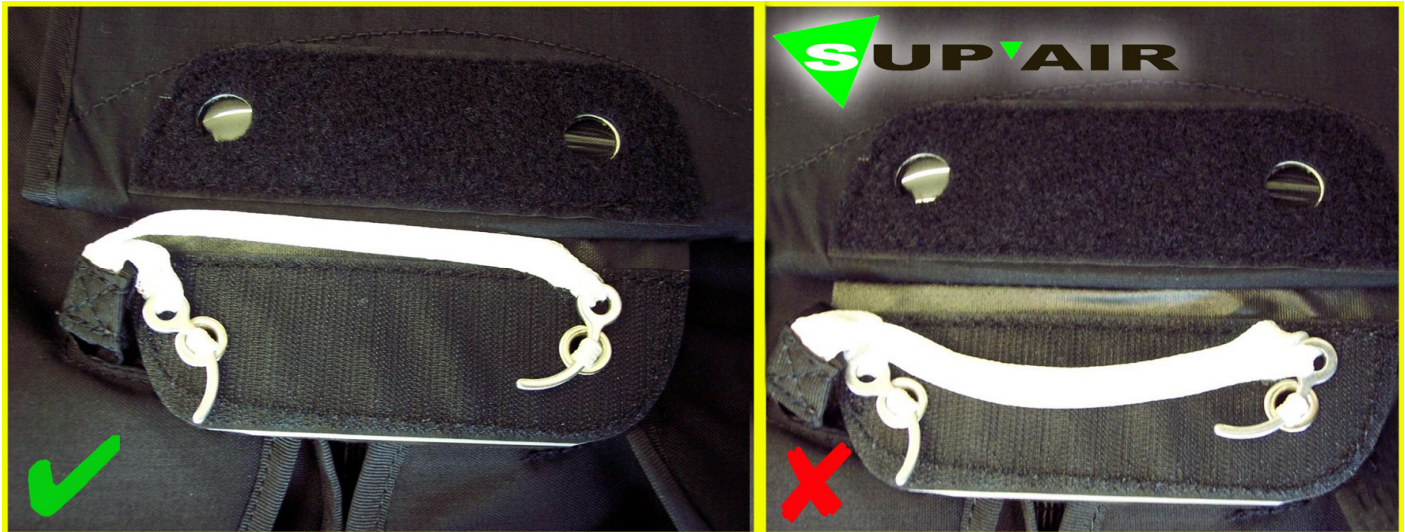
It has come to our attention that a small number of pilots have experienced difficulty in deploying their reserve parachutes during test deployments using Sup'Air AltiX and Evo XC harnesses (later designs). The white nylon braided cord attached to the deployment pins has become entangled between the velcro flaps over time making the force required to release the pins excessive. We recommend all owners of these harnesses to check their system and ensure that this cord does not run between the velcro flaps as shown in the attached picture. Alternative solutions of masking the male velcro side or sleeving the cord have also been used effectively.

We advise all pilots to check their pins and ensure that the braided cord is not trapped by the velcro at least 2 or 3 times per season.
